**Flood Control Project Maintenance  
Levee Inspections**

**Fall 2018 Levee Maintenance Deficiency Summary Report**

**Sacramento River Basin**

**Lake County Watershed Protection District**

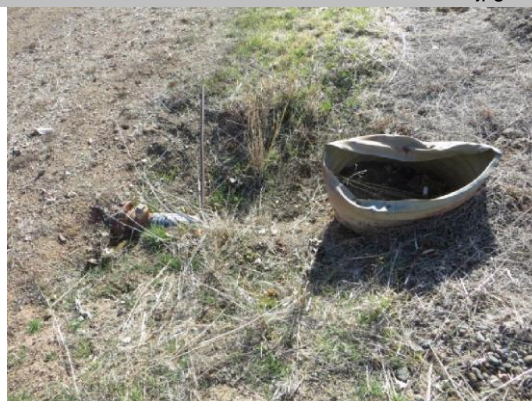
Photo 1 of 3 : UCIP\_FA\_2018\_26943\_49782.jpg

Comment Code					
Inspector Comment					
FS_ID:26943 DS_ID:21193 EP_NO: 5237 Repair Type: Non-Urgent Crossing Status: Found UCIP Comments: Pipe appears abandoned and should be done so properly. FIELD_STRUCT_DESC: *ABANDONED* 6-inch coated steel irrigation pipe possibly sleeved through an 8-inch steel pipe, 3 feet below the crown. Siphon breaker in 24-inch corrugated metal riser unit on the landside (LS) slope. Reinforced concrete cutoff wall at center of levee. Butterfly valve on the waterside (WS) at pump on concrete base on the WS bank. Pole on the WS berm with overhead power line supplying electricity to the pump. (Installed under Permit No. 5237, 1966 - Moitozo Brothers, Inc.). [Additional Reference(s): DWR Levee Log, 2005. USACE Sacramento O&M Manual 506.2, August 1961, (HLM 0.54)]. FS Date: 1/9/2014

Pipe and siphon breaker visible on LS slope.

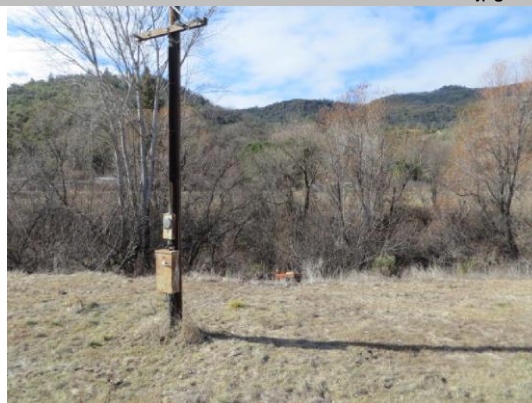
Photo 2 of 3 : UCIP\_FA\_2018\_26943\_49781.jpg

Power pole, meter, and pump visible on WS berm.

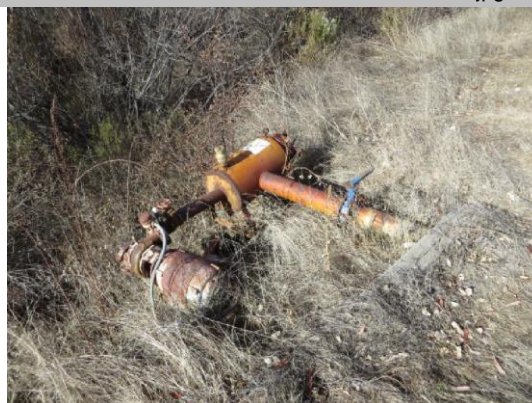
Photo 3 of 3 : UCIP\_FA\_2018\_26943\_49780.jpg

Comment Code						
Inspector Comment						
FS_ID:26943 DS_ID:21193 EP_NO: 5237 Repair Type: Non-Urgent Crossing Status: Found UCIP Comments: Pipe appears abandoned and should be done so properly. FIELD_STRUCT_DESC: *ABANDONED* 6-inch coated steel irrigation pipe possibly sleeved through an 8-inch steel pipe, 3 feet below the crown. Siphon breaker in 24-inch corrugated metal riser unit on the landside (LS) slope. Reinforced concrete cutoff wall at center of levee. Butterfly valve on the waterside (WS) at pump on concrete base on the WS bank. Pole on the WS berm with overhead power line supplying electricity to the pump. (Installed under Permit No. 5237, 1966 - Moitozo Brothers, Inc.). [Additional Reference(s): DWR Levee Log, 2005. USACE Sacramento O&M Manual 506.2, August 1961, (HLM 0.54)]. FS Date: 1/9/2014

Pump and butterfly valve on WS berm.

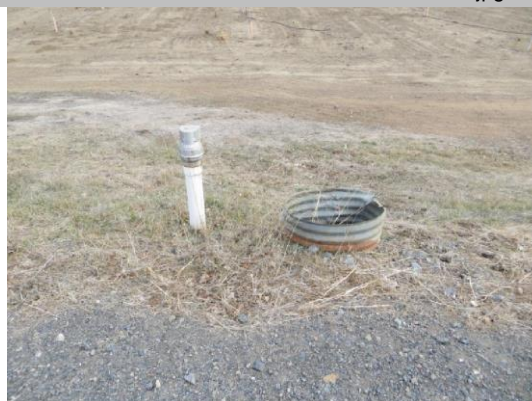
Photo 1 of 3 : UCIP\_FA\_2018\_26946\_49789.jpg

Comment Code						
Inspector Comment						
FS_ID:26946						
DS_ID:21196						
EP_NO: N/A						
Repair Type: Non-Urgent						
Crossing Status: Found						
UCIP Comments: Pump and pipe appear abandoned and should be done so properly.						
FIELD_STRUCT_DESC: *ABANDONED* 8-inch steel irrigation pipe through the levee, 3 feet below the crown. Siphon breaker in 24-inch corrugated metal riser unit on the landside (LS) slope. Pump on the waterside (WS) bank with a butterfly valve. Service pole on the WS berm. (Moitozo Brothers, Inc.). [Additional Reference(s): DWR Levee Log, 2005. USACE Sacramento O&M Manual 506.2, August 1961, (HLM 0.83)].						
FS Date: 1/9/2014

Siphon breaker in 24-inch cmp riser with vent on LS shoulder.

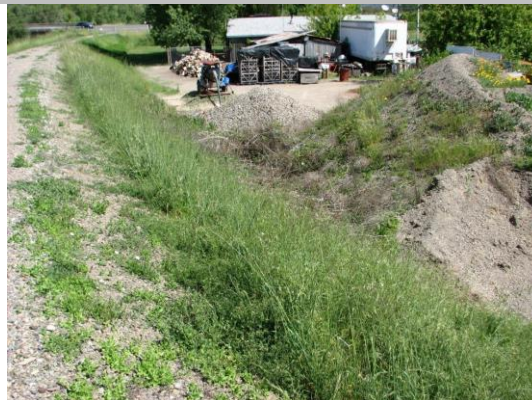
Photo 1 of 1 : FA\_2018\_NA0009\_3\_26\_20180905\_00014.jpg

5/2/2016: Remove large gravel piles from L/S toe.

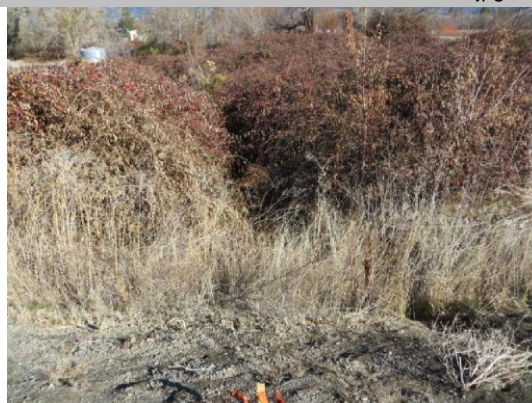
Photo 1 of 3 : UCIP\_FA\_2018\_26987\_49853.jpg

LM Start	2.26	Rating **	A/W	Issue No.	537
LM End	2.26	Issue Type +	Ma	Location *	
Category	Supplemental			GPS Latitude/Longitude	
				Start	End
Item	DWR UCIP LMA Responsibility			39.160327 °	39.160327 °
				-122.913998 °	-122.913998 °
DWR ID	21240				
Comment Code					
Inspector Comment					
FS_ID:26987					
DS_ID:21240					
EP_NO: N/A					
Repair Type: No Action Needed					
Crossing Status: Found					
UCIP Comments:					
FIELD_STRUCT_DESC: 2 of 2: 36-inch corrugated metal drainage pipe through the levee, 9 feet below the crown. Flap gate on the waterside (WS) end. Concrete headwalls on both ends. (two 36-inch pipes [HLM 2.26] retained under Automatic Board Order (ABO) issued as Permit No. 11460, 1975 - Robert L. and Lavona Gentry). [Additional Reference(s): DWR Levee Log, 2005. USACE Sacramento O&M Manual 506.2, August 1961, (HLM 2.26)].					
FS Date: 1/14/2014

Pipe and Concrete headwall visible on LS toe.

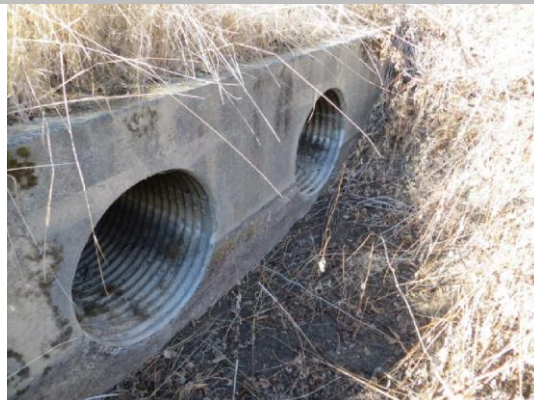
Photo 2 of 3 : UCIP\_FA\_2018\_26987\_49852.jpg

LM Start	2.26	Rating **	A/W	Issue No.	537 (cont)	
LM End	2.26	Issue Type +	Ma	Location *		
Category	Supplemental			GPS Latitude/Longitude		
				Start	End	
Item	DWR UCIP LMA Responsibility			39.160327 °	39.160327 °	
				-122.913998 °	-122.913998 °	
DWR ID	21240					
Comment Code						
Inspector Comment						
FS_ID:26987 DS_ID:21240 EP_NO: N/A Repair Type: No Action Needed Crossing Status: Found UCIP Comments: FIELD_STRUCT_DESC: 2 of 2: 36-inch corrugated metal drainage pipe through the levee, 9 feet below the crown. Flap gate on the waterside (WS) end. Concrete headwalls on both ends. (two 36-inch pipes [HLM 2.26] retained under Automatic Board Order (ABO) issued as Permit No. 11460, 1975 - Robert L. and Lavona Gentry). [Additional Reference(s): DWR Levee Log, 2005. USACE Sacramento O&M Manual 506.2, August 1961, (HLM 2.26)]. FS Date: 1/14/2014

Pipe and Concrete headwall visible on LS toe.

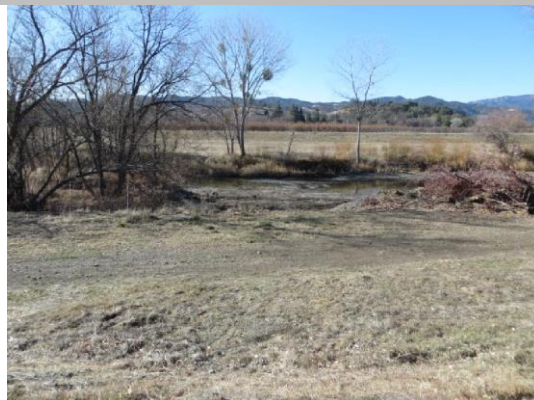
Photo 3 of 3 : UCIP\_FA\_2018\_26987\_49851.jpg

Pipe, Concrete headwall, and flap gate visible on WS berm.

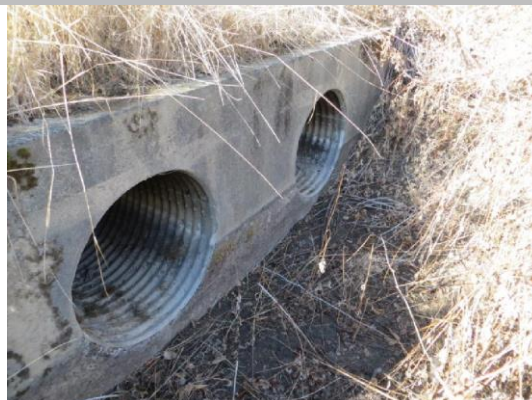
Photo 2 of 3 : UCIP\_FA\_2018\_26986\_49848.jpg

Concrete headwall and pipe visible on LS toe.

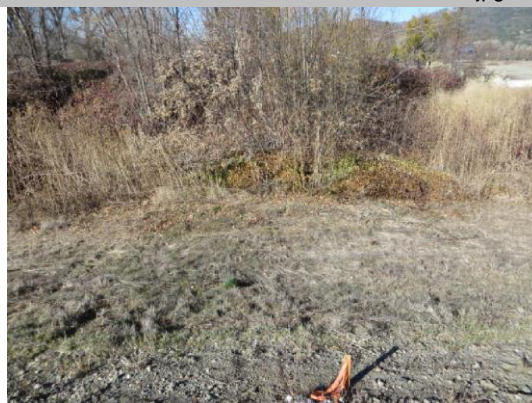
Photo 1 of 3 : UCIP\_FA\_2018\_27004\_49862.jpg

LM Start	2.35	Rating **	M	Issue No.	539
LM End	2.35	Issue Type +	Ma	Location *	
Category	Supplemental			GPS Latitude/Longitude	
				Start	End
Item	DWR UCIP LMA Responsibility			39.161002 °	39.161002 °
				-122.912843 °	-122.912843 °
DWR ID	21199				
Comment Code					
Inspector Comment					
FS_ID:27004 DS_ID:21199 EP_NO: 11460 Repair Type: Non-Urgent Crossing Status: Found UCIP Comments: Heavy vegetation on LS at inlet should be removed. FIELD_STRUCT_DESC: 42-inch corrugated metal drainage pipe through the levee, 10 feet below the crown. Flap gate on the waterside (WS) end. Concrete headwall on both ends. (42-inch pipe [HLM 2.35] retained under Automatic Board Order (ABO) issued as Permit No. 11460, 1975 - Robert L. and Lavona Gentry). [Additional Reference(s): DWR Levee Log, 2005. USACE Sacramento O&M Manual 506.2, August 1961, (HLM 2.35)]. FS Date: 1/14/2014

Heavy vegetation at inlet on LS toe.

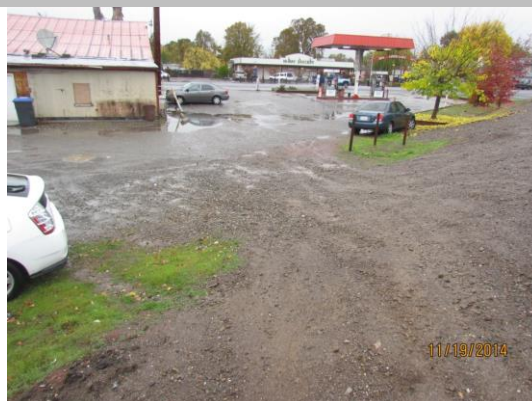
Photo 1 of 1 : FA\_2018\_NA0009\_3\_17\_20180905\_00011.jpg

LM Start	2.42	Rating **	M	Issue No.	17
LM End	2.42	Issue Type +	Ma	Location *	LS
Category	Earthen Levee			GPS Latitude/Longitude	
				Start	End
Item	Slope Stability			39.161802 °	39.161802 °
				-122.912020 °	-122.912020 °
DWR ID	DWR_NA0009_01_s_2013_17				
Comment Code					
S3 : Repair the levee slope damaged by vehicle traffic and prevent access where possible.					
Inspector Comment

View of the erosion caused by vehicle along the landside slope.

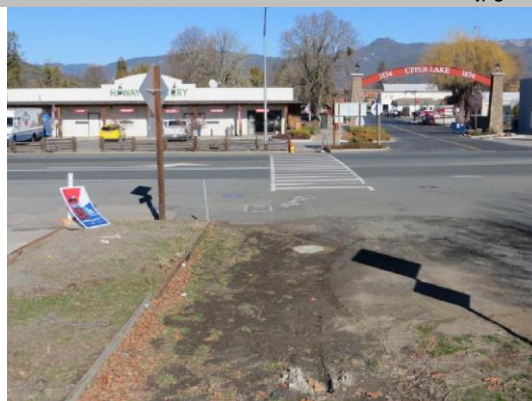
Photo 3 of 3 : UCIP\_FA\_2018\_53326\_50040.jpg

Comment Code						
Inspector Comment						
FS_ID:53326 DS_ID:21200 EP_NO: 11458 Repair Type: Urgent Crossing Status: Found UCIP Comments: 9/6/2018 Inspected this crossing per the request of LMA Rep, Scott Webb. WS pipe does not have a WS closure device and has caused flooding of the roadway due to the flat LS pipe slope and roadway. Classifying Urgent until the flooding risk is reduced by the installation of a WS gate valve (D. Sanoski - DWR UCIP). FIELD_STRUCT_DESC: 36-inch corrugated metal drainage pipe through the levee, 8 feet below the crown. 24-inch by 36-inch drainage drop inlet visible at edge of pavement on Highway 20. Open on the waterside (WS) end. (Pipe retained through the levee under Automatic Board Order (ABO) issued as Permit No. 11458, 1975 - Fernande and Guido Deghetaldi). [Additional Reference(s): DWR Levee Log, 2005]. FS Date: 9/6/2018 1:04:00 PM

Stormdrain drop inlet visible at edge of pavement on HWY 20.

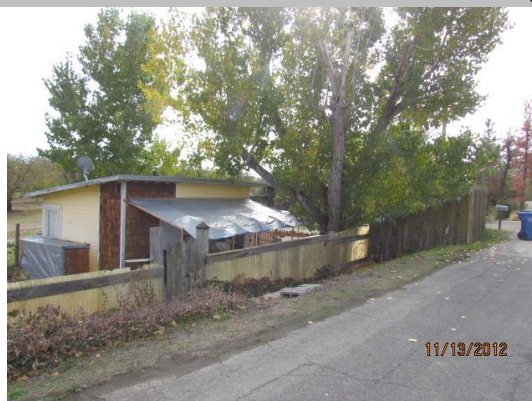
Photo 1 of 1 : FA\_2018\_NA0009\_3\_7\_20180905\_00005.jpg

LM Start	2.47	Rating **	M	Issue No.	7
LM End	2.59	Issue Type +	En	Location *	LS
Category	Earthen Levee			GPS Latitude/Longitude	
				Start	End
Item	Encroachments			39.161692 °	39.160217 °
				-122.911748 °	-122.912957 °
DWR ID	DWR_NA0009_01_s_2012_7				
Comment Code					
BU : Building					
Inspector Comment

View of a building & fence along the toe of the levee.

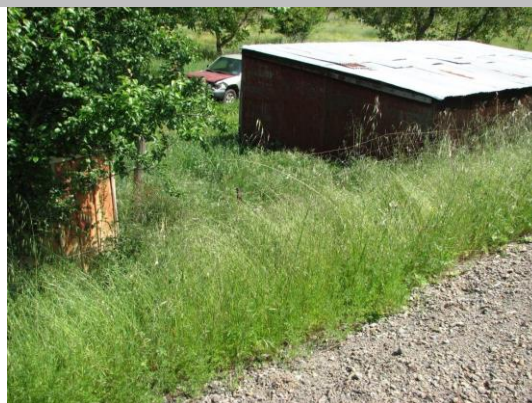
Photo 1 of 1 : FA\_2018\_NA0009\_3\_31\_20180905\_00015.jpg

5/2/2016: Remove or relocate 2 unpermitted sheds on L/S slope and toe.

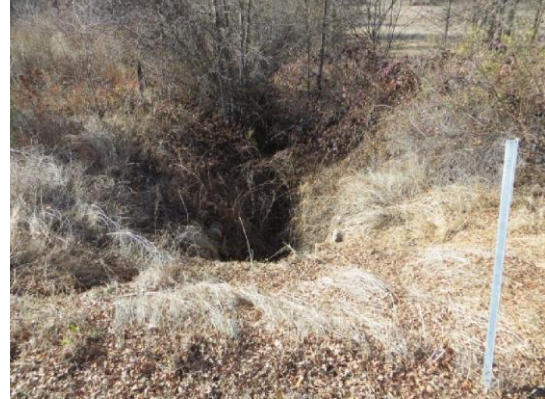
Photo 1 of 3 : UCIP\_FA\_2018\_27066\_50049.jpg

LM Start	0.14	Rating **	A/W	Issue No.	33	
LM End	0.14	Issue Type +	Ma	Location *		
Category	Supplemental			GPS Latitude/Longitude		
				Start	End	
Item	DWR UCIP LMA Responsibility			39.187919 °	39.187919 °	
				-122.908631 °	-122.908631 °	
DWR ID	21201					
Comment Code						
Inspector Comment						
FS_ID:27066 DS_ID:21201 EP_NO: 11485 Repair Type: No Action Needed Crossing Status: Found UCIP Comments: FIELD_STRUCT_DESC: 42-inch corrugated metal drainage pipe through the levee, 8.5 feet below the crown. Flap gate on the waterside (WS). Concrete headwalls on both ends. (42-inch pipe [HLM 0.13] retained under Automatic Board Order (ABO) issued as Permit No. 11485, 1975 - John and Vivian Strickfaden). [Additional Reference(s): DWR Levee Log, 2005. USACE Sacramento O&M Manual 506.2, August 1961, (HLM 0.13)]. FS Date: 1/14/2014

Pipe and headwall visible at LS toe in drainage swale.

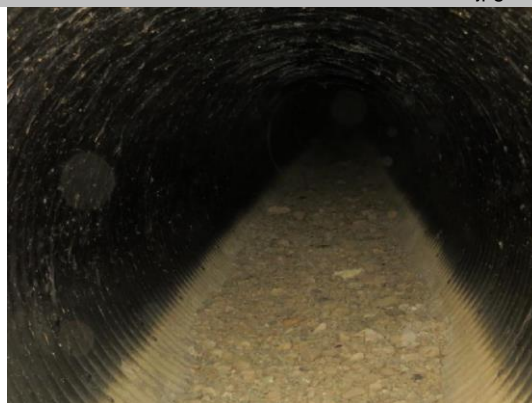
Photo 3 of 3 : UCIP\_FA\_2018\_27066\_50047.jpg

Pipe with some sediment at flowline.

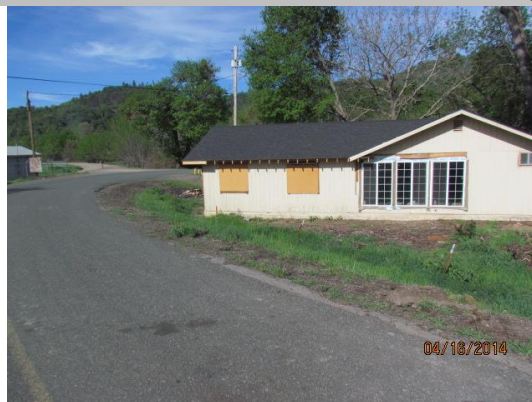
Photo 1 of 1 : FA\_2018\_NA0009\_4\_1\_20180905\_00001.jpg

View of the building on the landside toe.

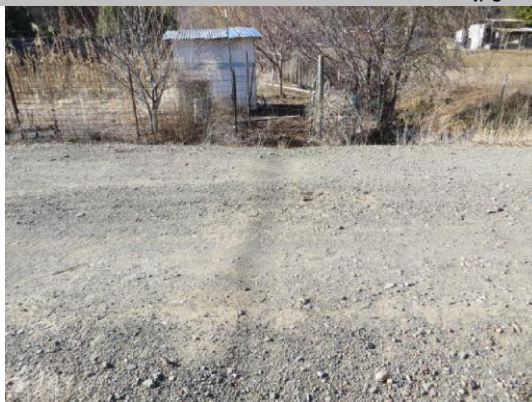
Photo 3 of 3 : UCIP\_FA\_2018\_27563\_51180.jpg

cut across levee crown visible along pipe alignment.

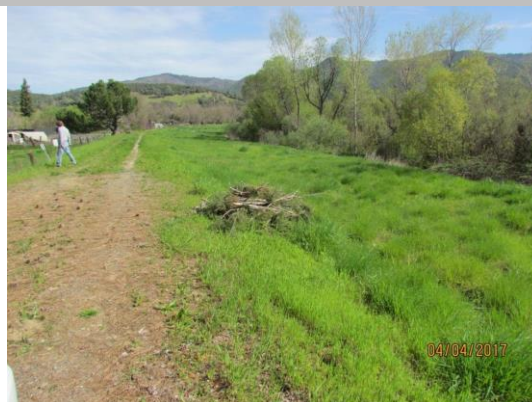
Photo 1 of 1 : FA\_2018\_NA0009\_4\_30\_20180905\_00012.jpg

View of the prunings along the waterside slope.

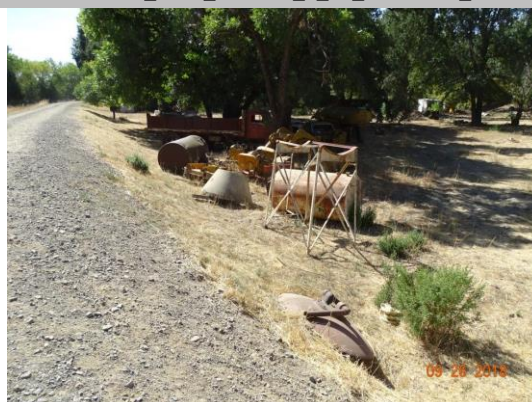
Photo 1 of 1 : FA\_2018\_NA0009\_4\_31\_20181009\_00051.jpg

View of equipment along the landside toe.

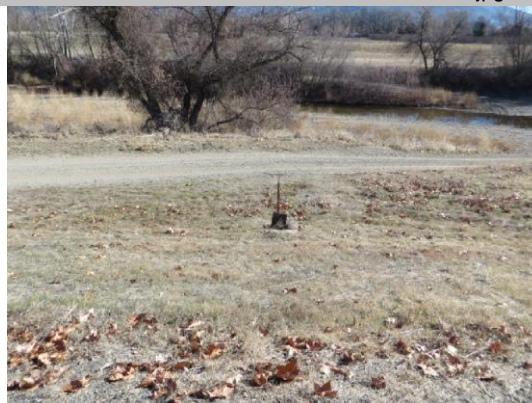
Photo 2 of 2 : UCIP\_FA\_2018\_27606\_51249.jpg

T-post at WS toe may indicate location of pipe end. Covered with soil.

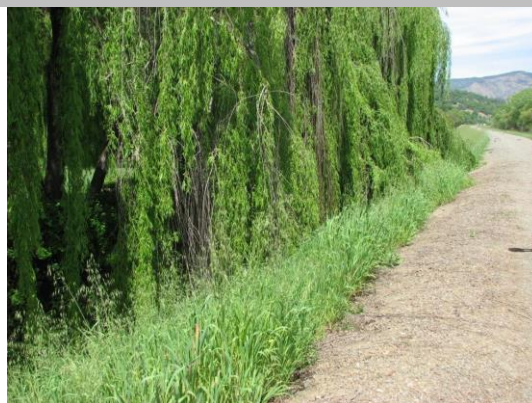
Photo 1 of 1 : FA\_2018\_NA0009\_4\_18\_20180905\_00009.jpg

View of the overgrown willow trees at the landside levee slope.

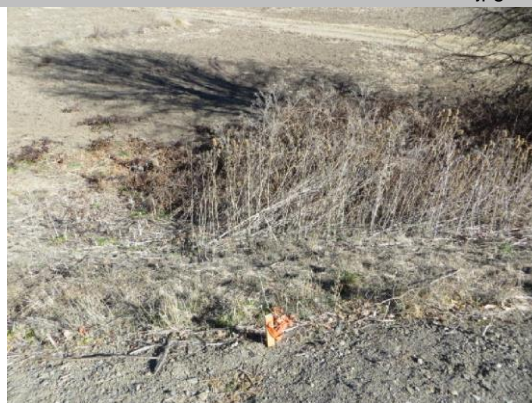
Photo 1 of 3 : UCIP\_FA\_2018\_27863\_51542.jpg

Pipe visible at LS toe covered with vegetation.

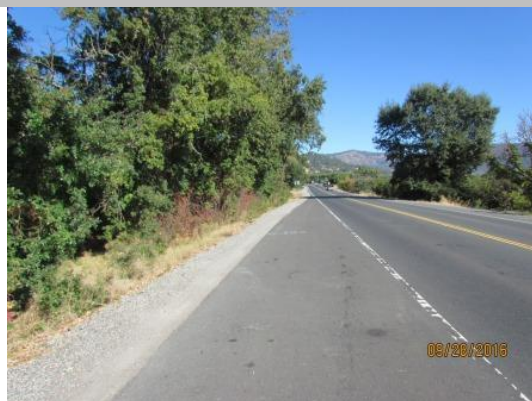
Photo 1 of 1 : FA\_2018\_NA0009\_5\_14\_20180905\_00005.jpg

View of the waterside vegetation looking upstream.

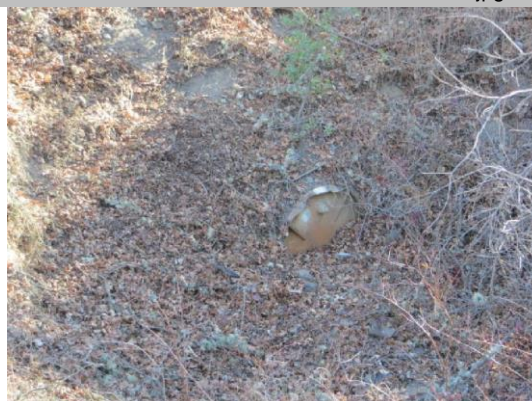
Photo 1 of 3 : UCIP\_FA\_2018\_27893\_51595.jpg

Plugged pipe visible on WS toe of roadway.

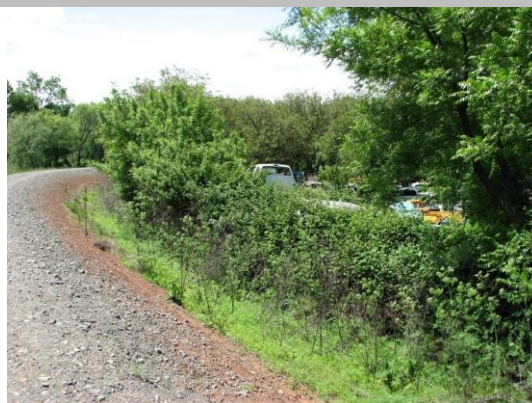
Photo 1 of 1 : FA\_2018\_NA0009\_5\_11\_20180905\_00002.jpg

5/2/2016: Fence along vehicle junk yard is covered in dense growth of bushes and vines.
